CASE STUDY | Automotive Fueling Service Station

PROJECT DATES:	2009 - 2012
Site:	Former automotive fueling and service station located on an acre of land at the intersection of two primary transportation arteries.
CONTAMINANTS OF CONCERN:	Petroleum impacts: benzene, toluene, ethylbenzene and xylenes (BTEX), TPH-GRO, and methyl tert-butyl ether (MTBE).
PROBLEM:	Residual petroleum impacts were present in soil and groundwater at concentrations above applicable criteria specified by the Indiana Department of Environmental Management (IDEM).
SITUATION:	This project required resolution within an unusually brief time frame and specific budget parameters. The client used their own assets to pay for remediation efforts, and before they could start the project, they needed a guaranteed maximum cost for completion within a specific time frame to allow results for site redevelopment.
ACUITYES DIFFERENCE:	Developed a <i>customized</i> reagent that delivered successful remediation results despite logistical challenges.

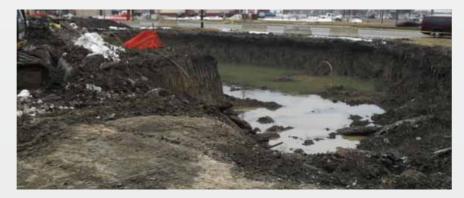
THE PROCESS: **DURING REMEDIATION:** Excavation was initiated along a utility trench (background of the photo) that contained a high-pressure natural gas line and a fiber-optic cable. The excavation was staged to remove as much of the source area as practical without damaging the buried utilities.

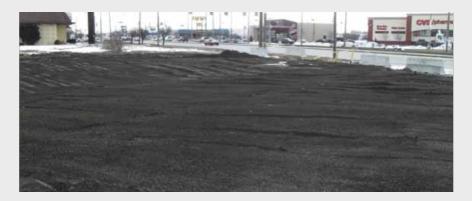
AFTER REMEDIATION: Groundwater monitoring over nine quarters produced sufficient documentation to support Site closure under the Indiana Voluntary Remediation Program (VRP).
